# II Tech Tip Thursday

## GNSS interference localization with built-in spectrum analyzer

[Tech Tip Thursday CCFS 2026-#1]

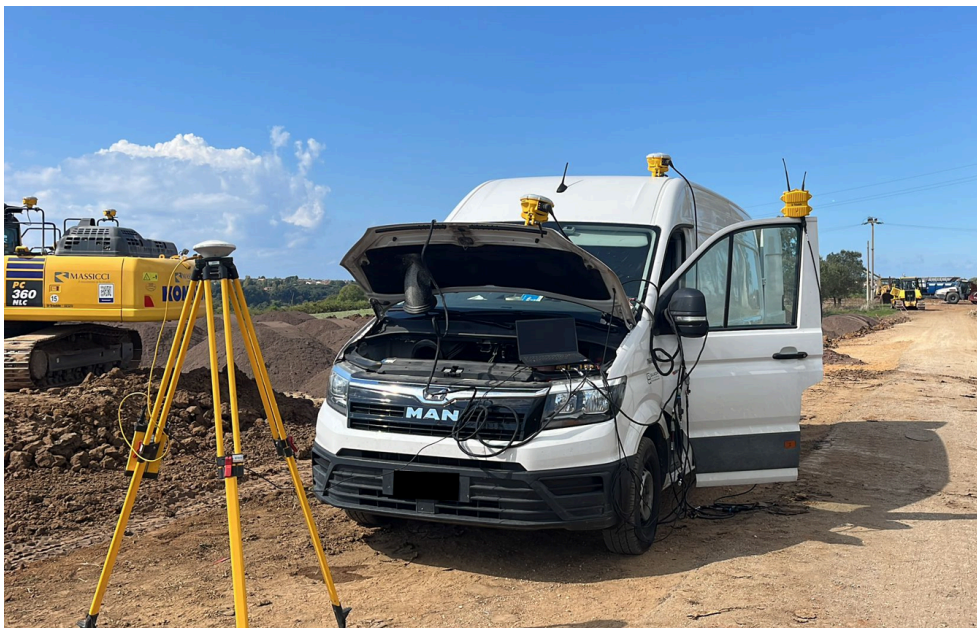
After a long troubleshooting of guessing and swapping components, the field engineer used the R780's built-in Spectrum Analyzer function. This tool is accessible via the receiver's web interface or directly on a controller like the Trimble TSC5. It provides a real-time graph of the radio frequency (RF) environment, allowing the technician to "see" invisible interference.

The following features were critical in diagnosing the problem:

| Feature | Description | How it helped find the issue |
|---|---|---|
| Select graph type | Allows choosing between different views of the spectral data, such as Spectrum Analyzer (live), Spectrum History, and Spectrogram Toolkit. | Viewing the Spectrum Analyzer (real-time plot of power vs. frequency) was essential for an immediate view of the interference spike and its magnitude. |
| Select band (L1, L2, etc.) | Allows the user to select the specific GNSS frequency band to analyze (e.g., L1 or L2). | By focusing on the L1 band (around 1575.42 MHz), the user confirmed the interference was directly impacting the primary GNSS frequency, which directly correlated with the degraded performance. |
| Filtering mode | Controls how the spectral data is processed, with options like No Filtering, Max Hold, and Filtered Spectrum. | Max Hold was selected to capture the maximum power level of the interference over time. This is crucial for identifying intermittent signals that might otherwise be missed. |
| Visualization options | Includes a checkbox to Show Center Frequencies. | This feature displays vertical lines indicating the expected center frequencies of various GNSS signals. This was vital for quickly confirming the spike was landing directly on the protected L1 frequency. |
| Power (dB) Scale | The vertical axis of the graph displays the measured signal strength in decibels (dB). | The sudden and distinct spike in power (over 45 dB) clearly highlighted the presence of a strong, unnatural signal (the jamming) far above the normal noise floor. |
| Frequency (MHz) Scale | The vertical axis of the graph displays the measured signal strength in decibels (dB). | This confirmed the interference was operating within the protected GNSS bands, specifically centered around the 1575.42 MHz L1 frequency. |

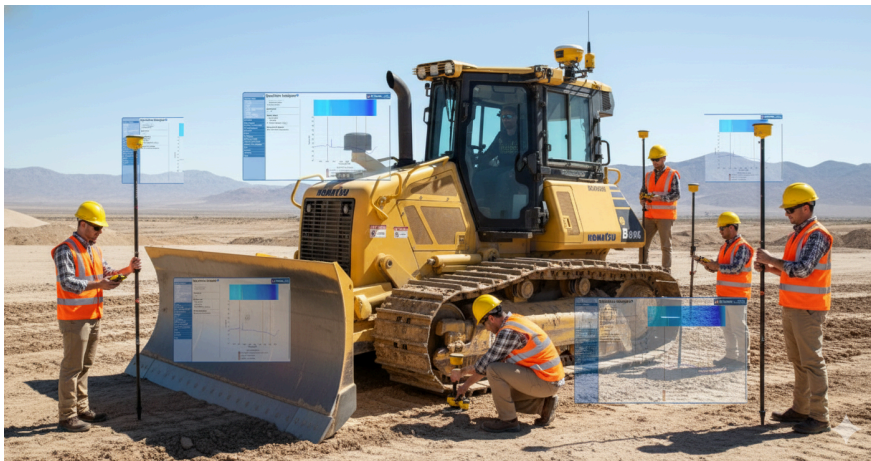
These tools were specifically used by the technician to turn an invisible RF problem into a simple "hot and cold" search.

**Observation 1:** A high-power spike was immediately visible on the spectrum analyzer when the field engineer was near the dozer. The interference was clearly affecting the L1 band.

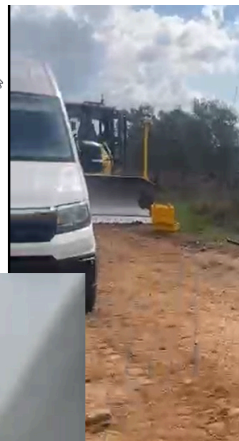
20 meters away the  
issue is gone

**Observation 2:** The field engineer walked approximately 20 meters away from the machine. As he did, he observed the spectrum on the TSC5 return to a normal, flat signal, and the interference spike completely disappeared

This test definitively confirmed the interference was not from a site-wide external source, but was emanating from the dozer itself. The technician also briefly disconnected the Trimble system's radio to rule it out as the source, with no change to the interference

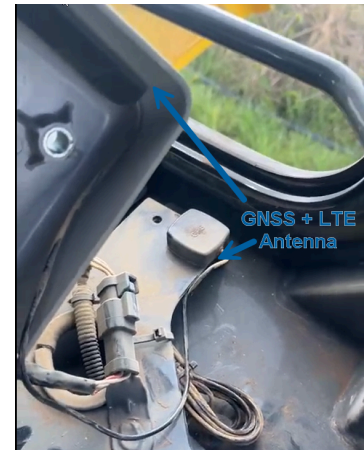
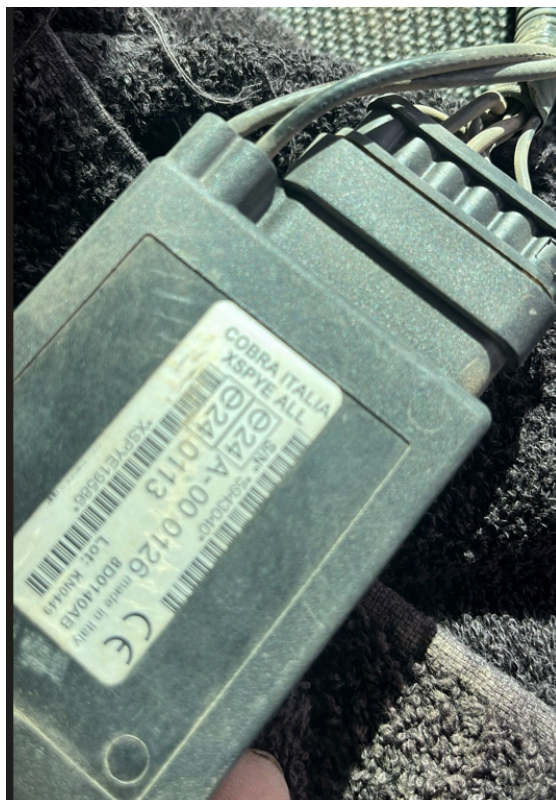
Now certain the source was inside the cab, a physical inspection began. The technician quickly located a small, non-Trimble GPS antenna mounted on the console. This antenna was traced to a third-party vehicle security and location system.

This third-party device's antenna had failed. Instead of passively receiving signals, it was malfunctioning and actively transmitting powerful RF noise. This "loud" signal was "deafening" the highly sensitive GNSS receiver, which is designed to listen for extremely faint signals from satellites in orbit. The resolution was simple: the defective COBRA ITALIA unit was disconnected. As soon as it was powered down, the spikes on the spectrum analyzer vanished. The GNSS receiver's satellite count immediately returned to a healthy 30+, the RTK "Fixed" solution was re-established, and the dozer was fully operational.
